DAMAGE ANALYSIS OF WATER SUPPLY PIPES DUE TO THE 2004 NIIGATA-KEN CHUETSU, JAPAN EARTHQUAKE

K. Hasegawa¹, H. Sakai¹, K. Wakamatsu² and T. Sato³

ABSTRACT

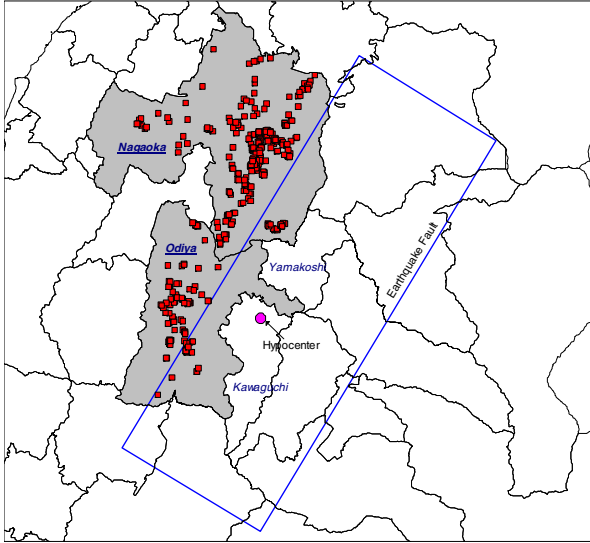
Figure 1. Distribution of water supply pipeline damage. (gray area: research target)

Overlaying Figs. 1 and 2 in GIS reveals the distribution characteristics of water supply pipeline damage based on the geomorphologic classification map and earthquake fault locations. Namely, the severely damaged zone is distributed in the buffer zone along the earthquake fault to the west. Within the zone, the damage locations are focused at the boundaries between geomorphologic classifications, such as between alluvial fans and gravelly terraces, or gravelly terraces and hills.

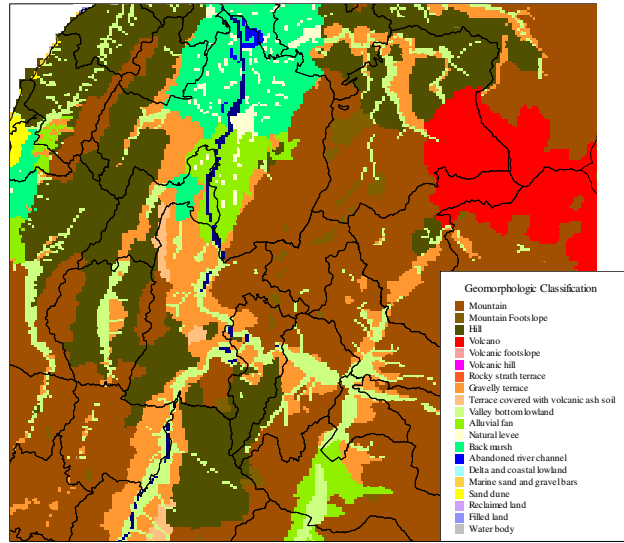
Figure 2. Geomorphologic classification map.

The extensive ground motion is assumed to have caused significant soil strain in artificially altered land within the geomorphologic boundary zones, as is evident in the damage distribution. In general, the boundary zones of geomorphologic classifications correspond to slope zones, which are developed into residential areas.

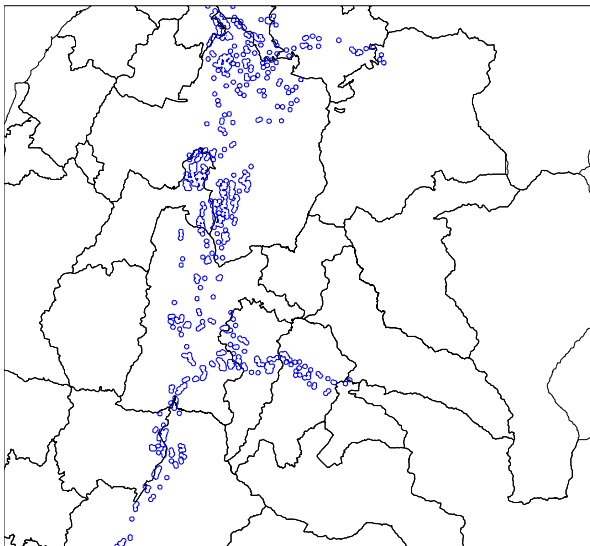
Figure 3. Distribution of liquefaction.

Liquefaction zones are spread widely, not only along the alluvial plains but also on terraces. The overlay analysis of damage and liquefaction indicates that 16 percent of Ojiya city is within the liquefaction zone, and 8 percent of Nagaoka city is within the liquefaction zone.

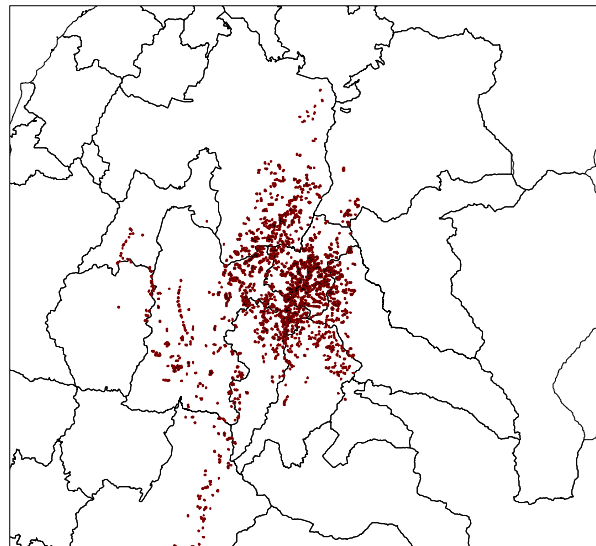
Figure 4. Distribution of landslides.

In contrast, landslides had little effect on water supply pipes. Overlaying the landslide map on the damage distribution reveals only 2 damaged sites in Ojiya city and 10 damaged sites in Nagaoka city located within the hazard zone because most landslides occurred in the mountains or on hills. However, lifelines were severely damaged due to landslides in areas such as the new town of "Takamachi," located on a hill in Nagaoka city.

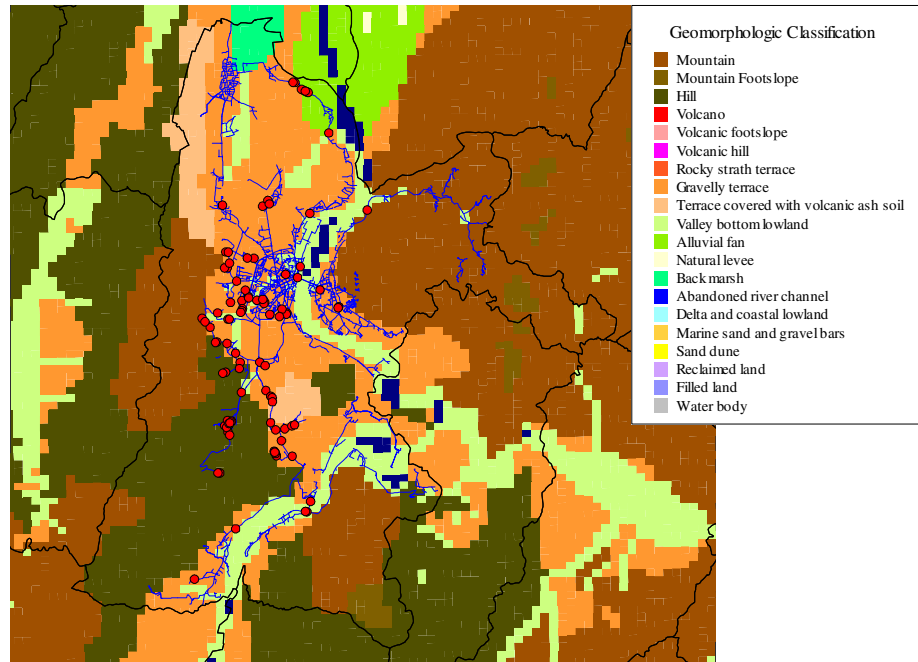
Figure 5. Distribution of damage and pipelines in Ojiya city.

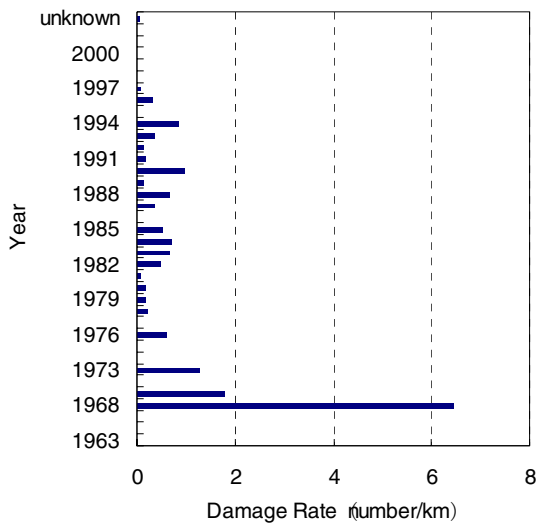
It was reported that older pipelines should be changed to improve earthquake resistance (Ministry of Health, Labor and Welfare 2005), however few studies have analyzed the relationship between pipeline age and the damage rate. Figure 6 compares the damage rate to the age of pipelines in Ojiya city. The damage rates of pipelines laid before 1974 were confirmed to be higher than those installed after 1975.

Figure 6. Damage Rate per Year in Ojiya

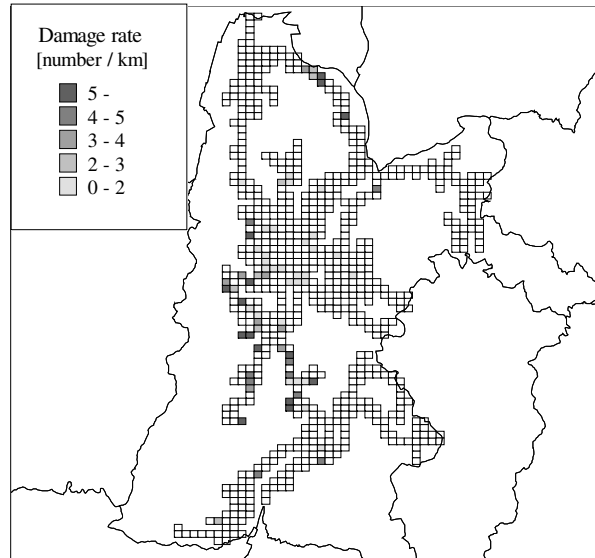
Figure 7. Damage Rate to each Grid in Ojiya

Grid based damage rates in Ojiya city are shown in Fig.7. Grid based spatial densities of water supply pipelines are shown in Fig.8. Fig. 7 confirms that grids with higher damage rates are distributed outside of the central zone in Ojiya city. On the other hand Fig. 8 indicates that the grid based densities of pipeline distributing outside of the central zone are lower than those in the central zone. Table 7 shows the average damage rate to classes of pipeline density. Two kinds of damage rate are computed, one is total average damage rate and the other is average of grid-based damage rate. Both of them show the same tendency that as the density of pipelines decreases, the higher damage rates become.

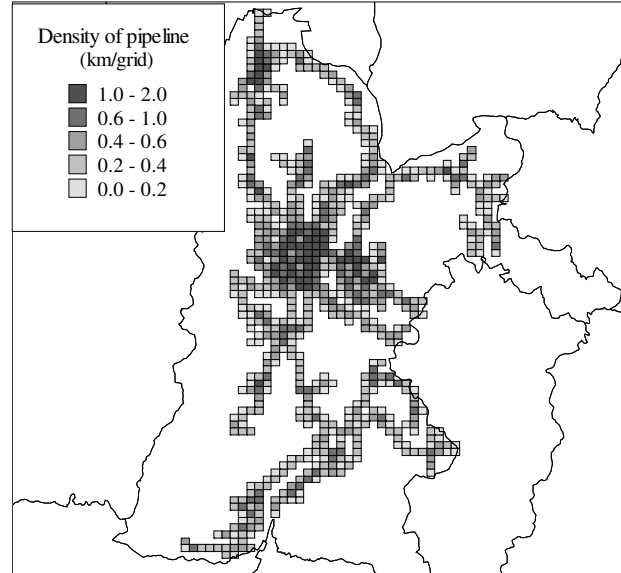
Figure 8. Distribution of spatial density of water supply pipes in Ojiya city.
